## Burning car at a Fastned charging station in Beilen

# Case debrief: fire at the Fastned station in Beilen on 23 November 2023

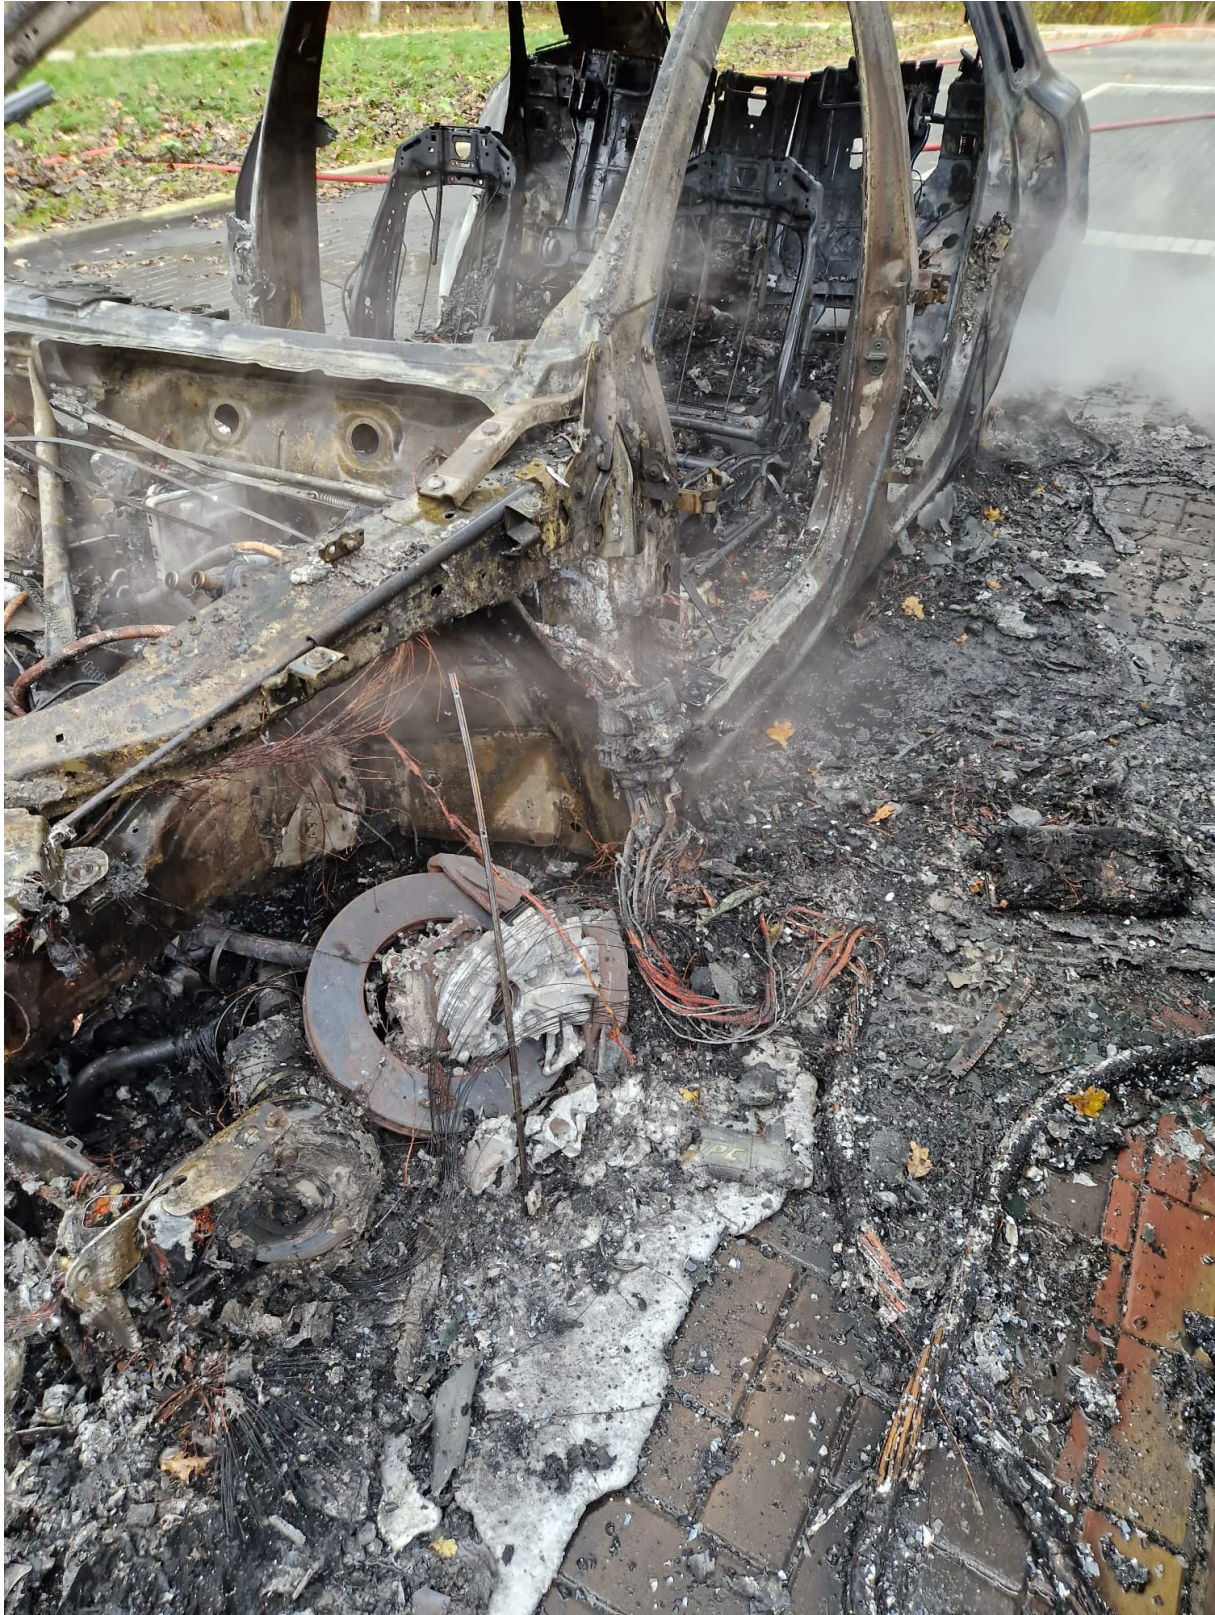
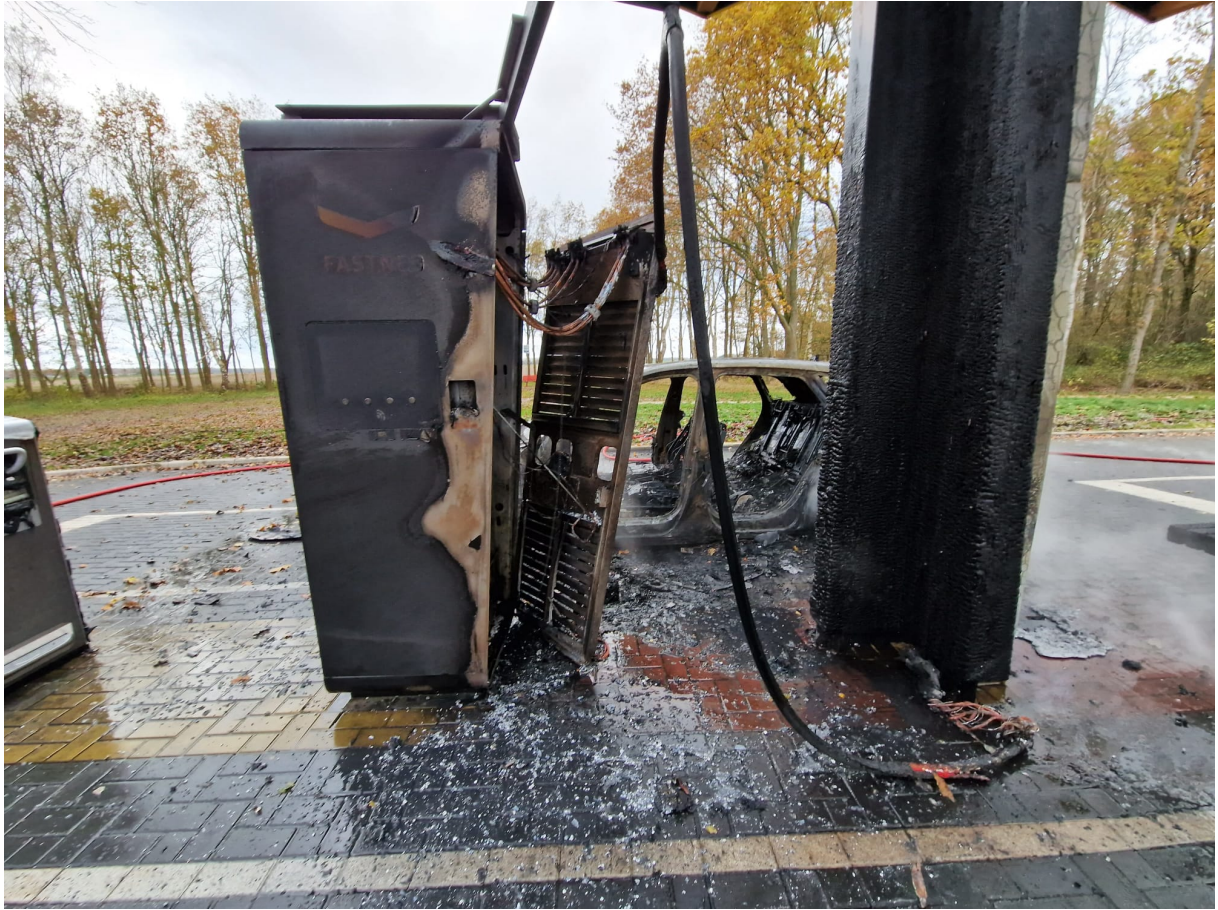
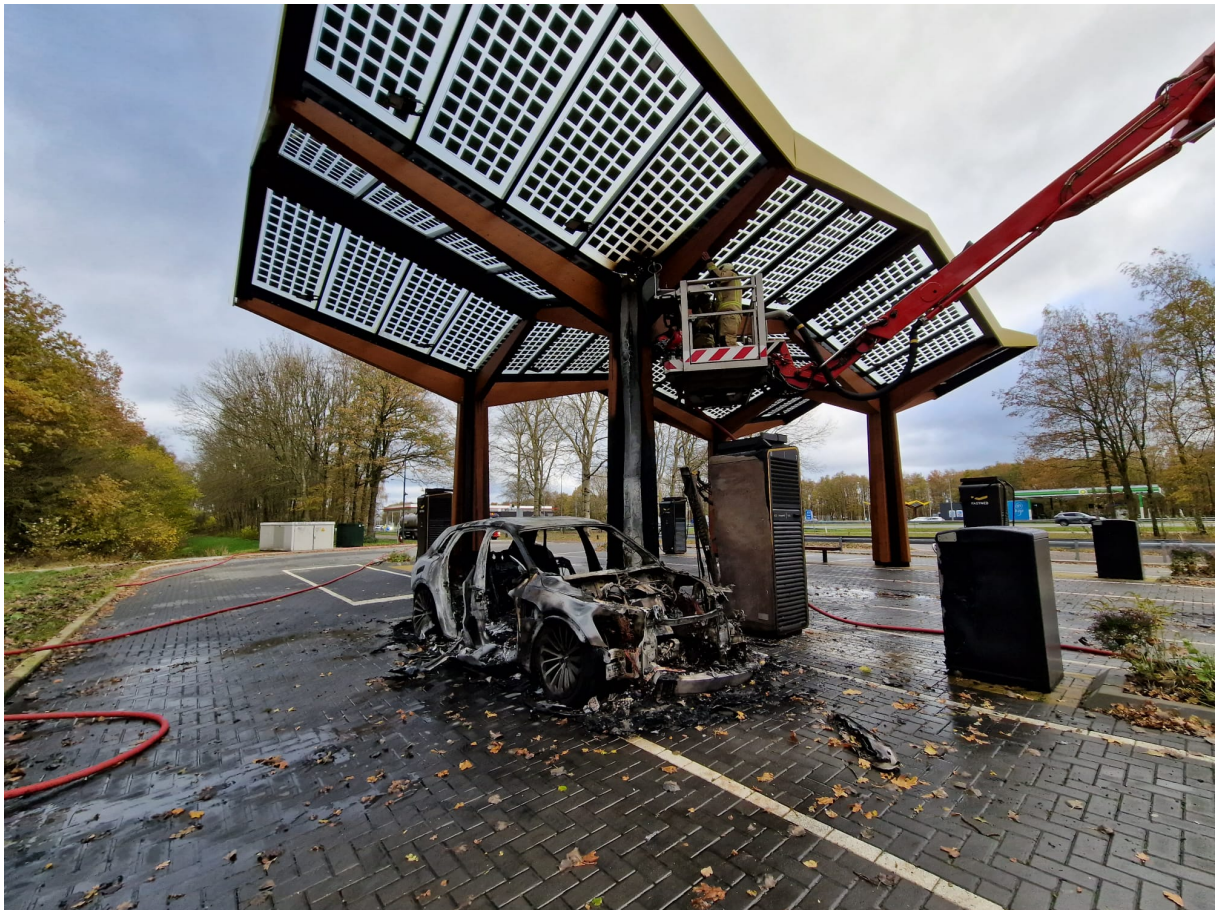
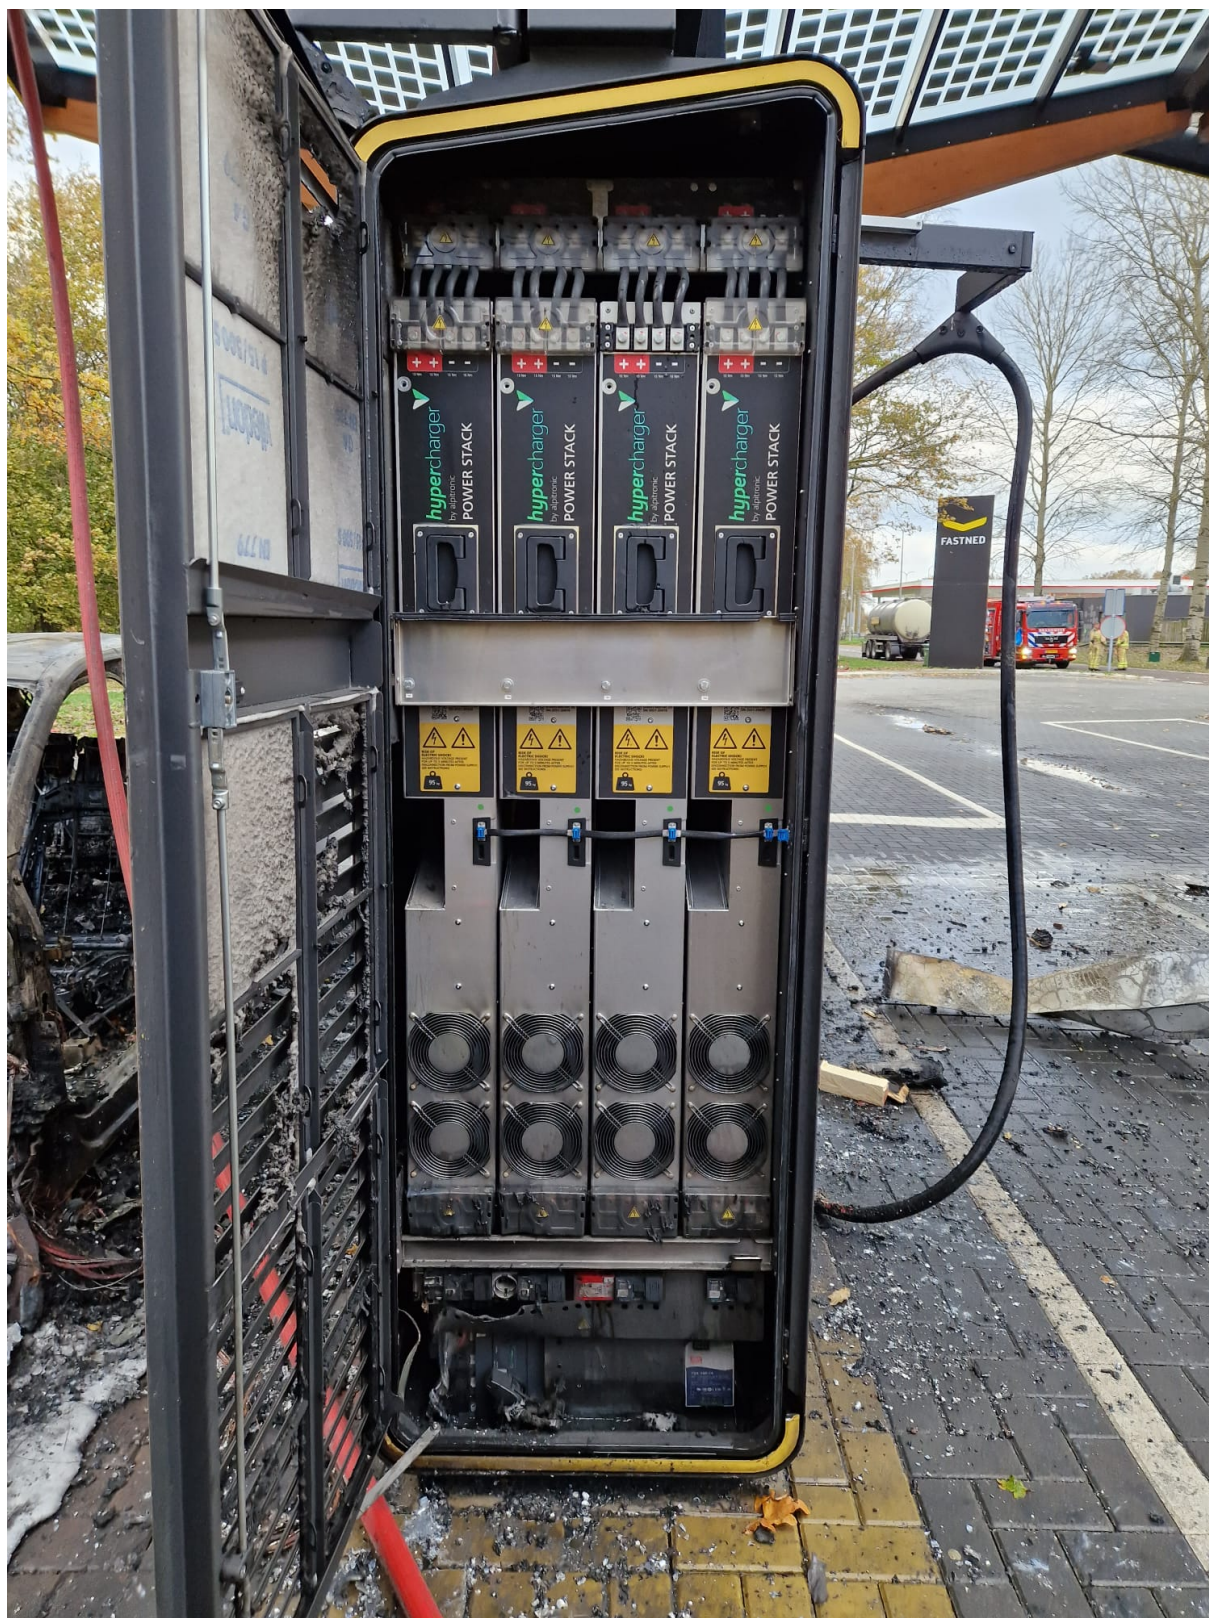
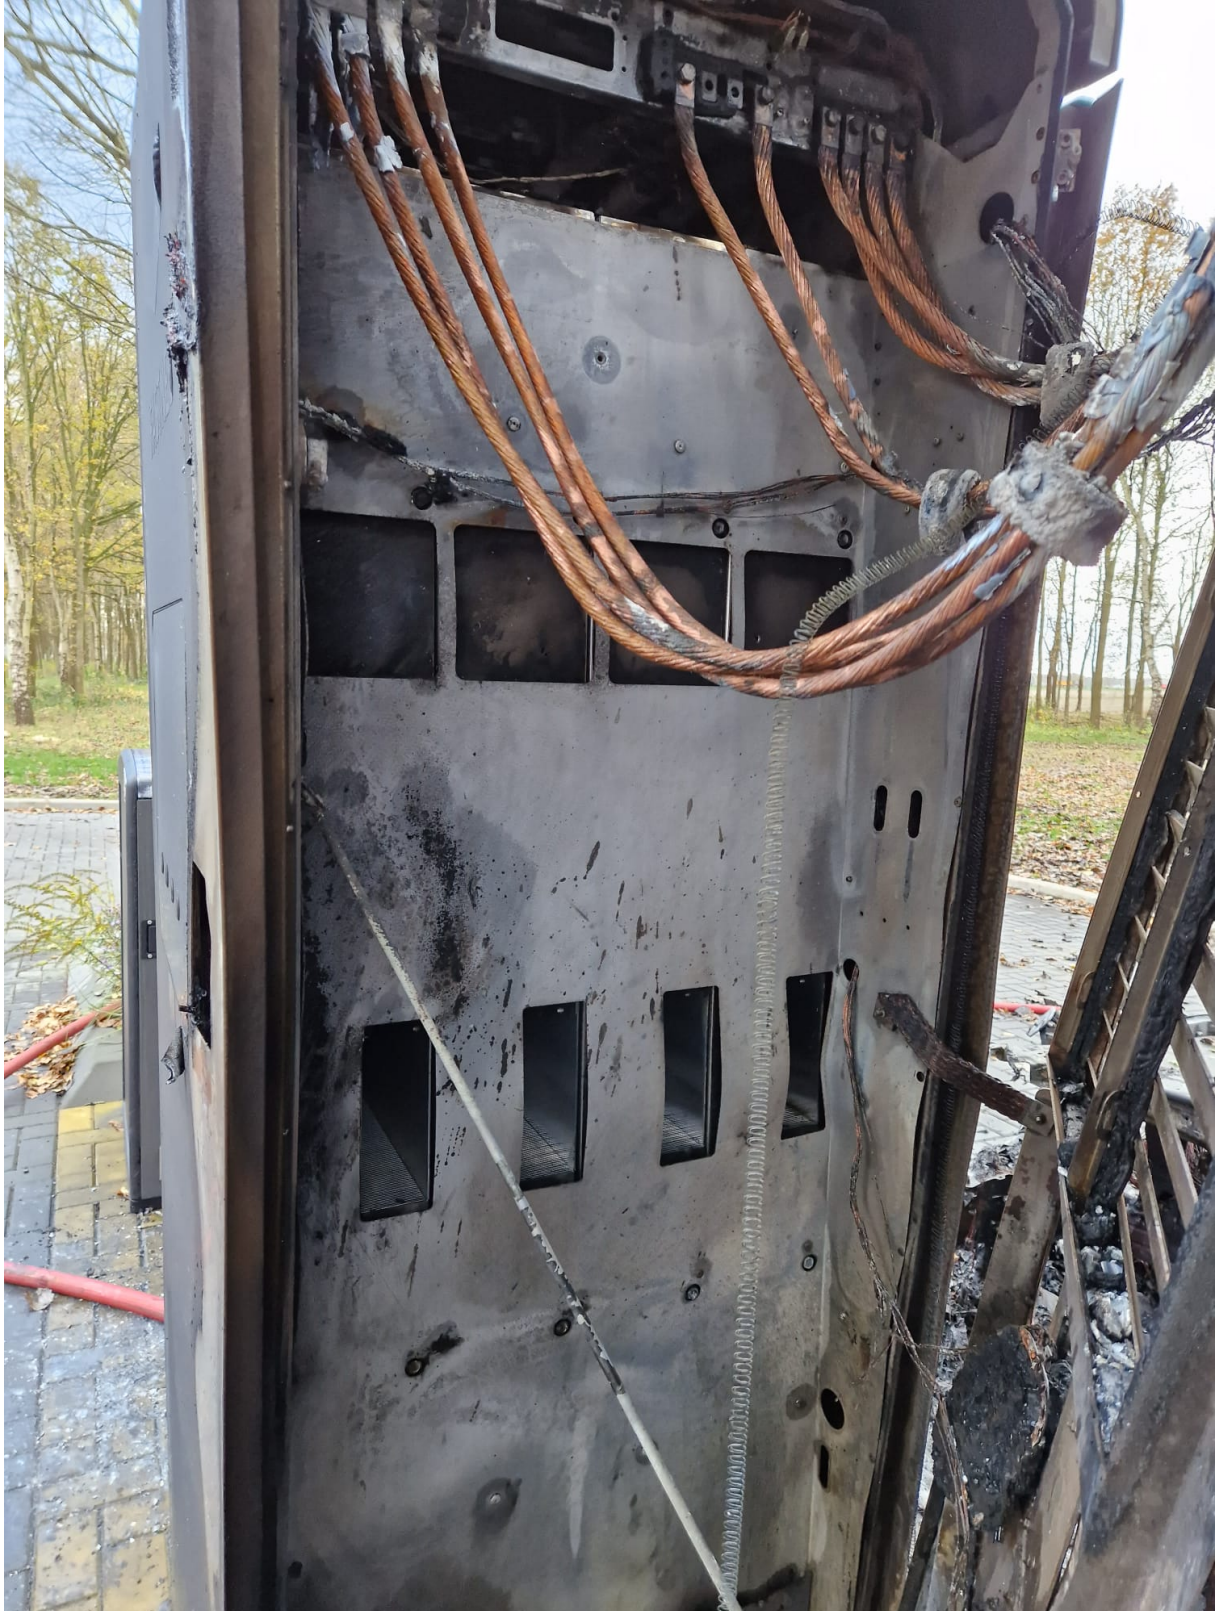
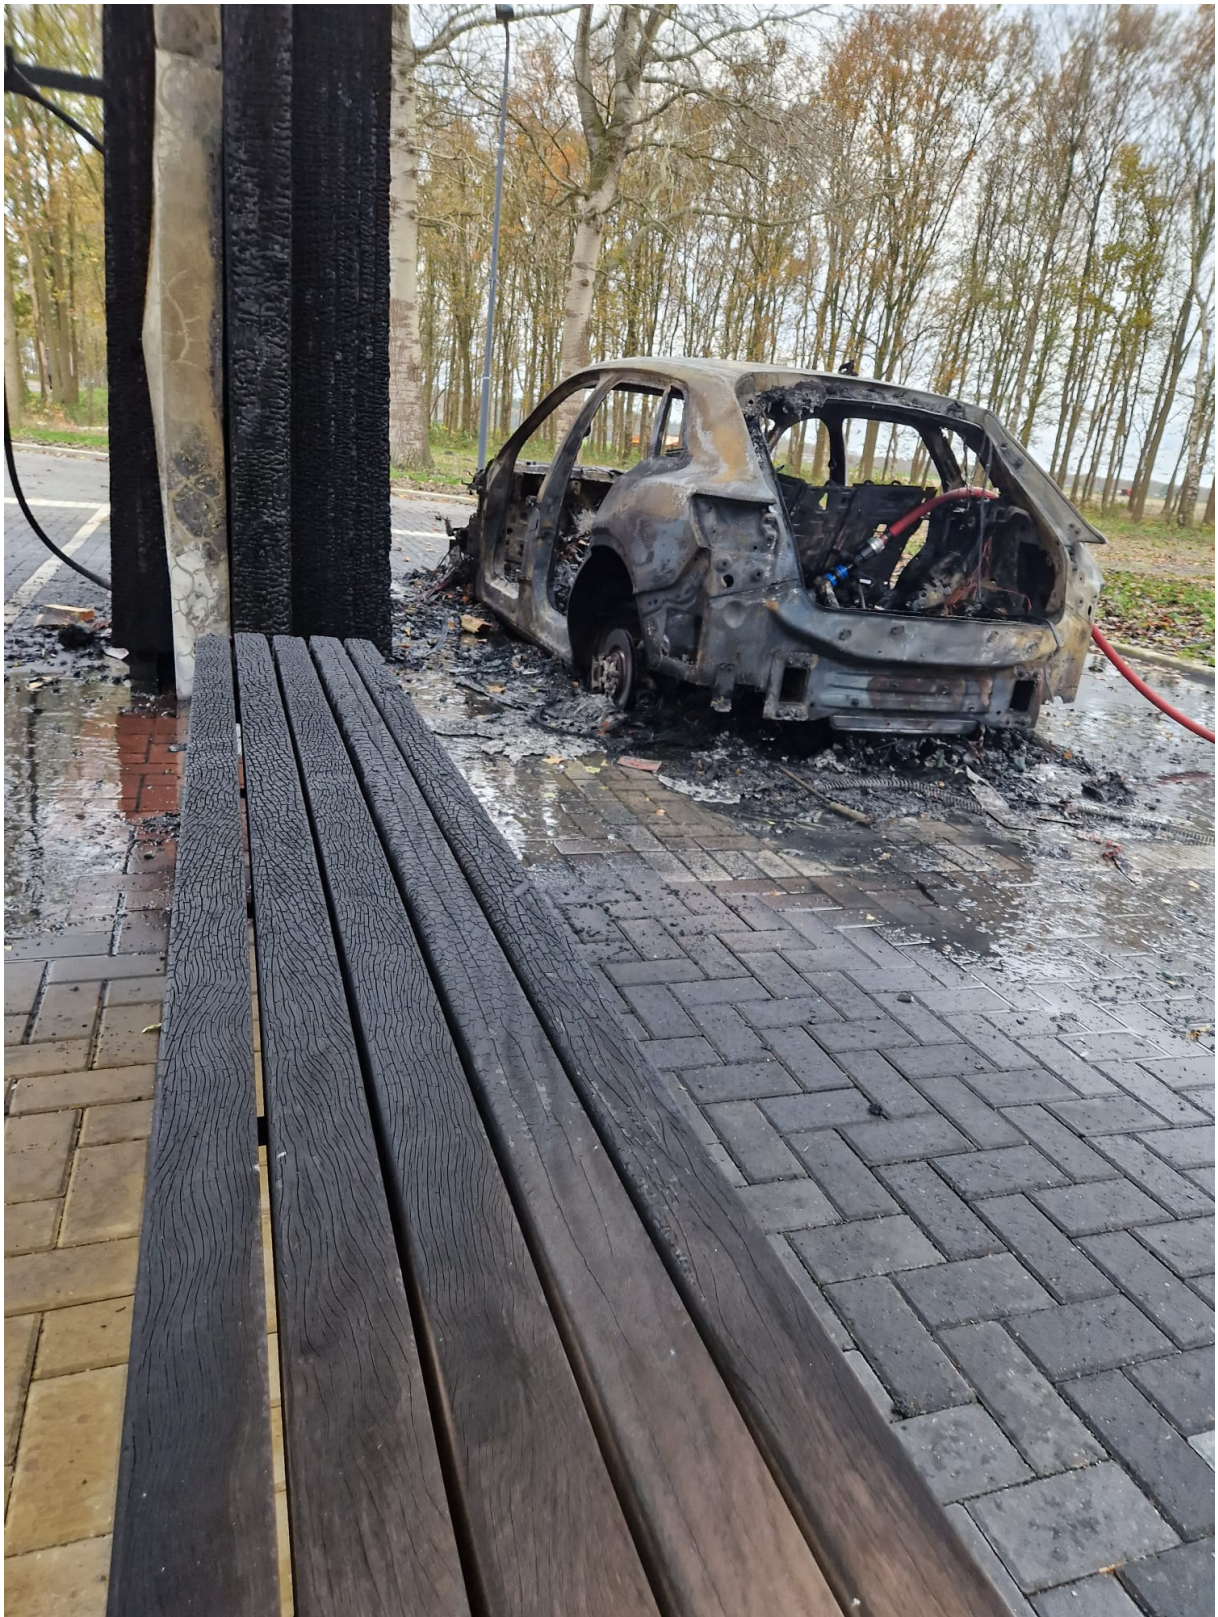
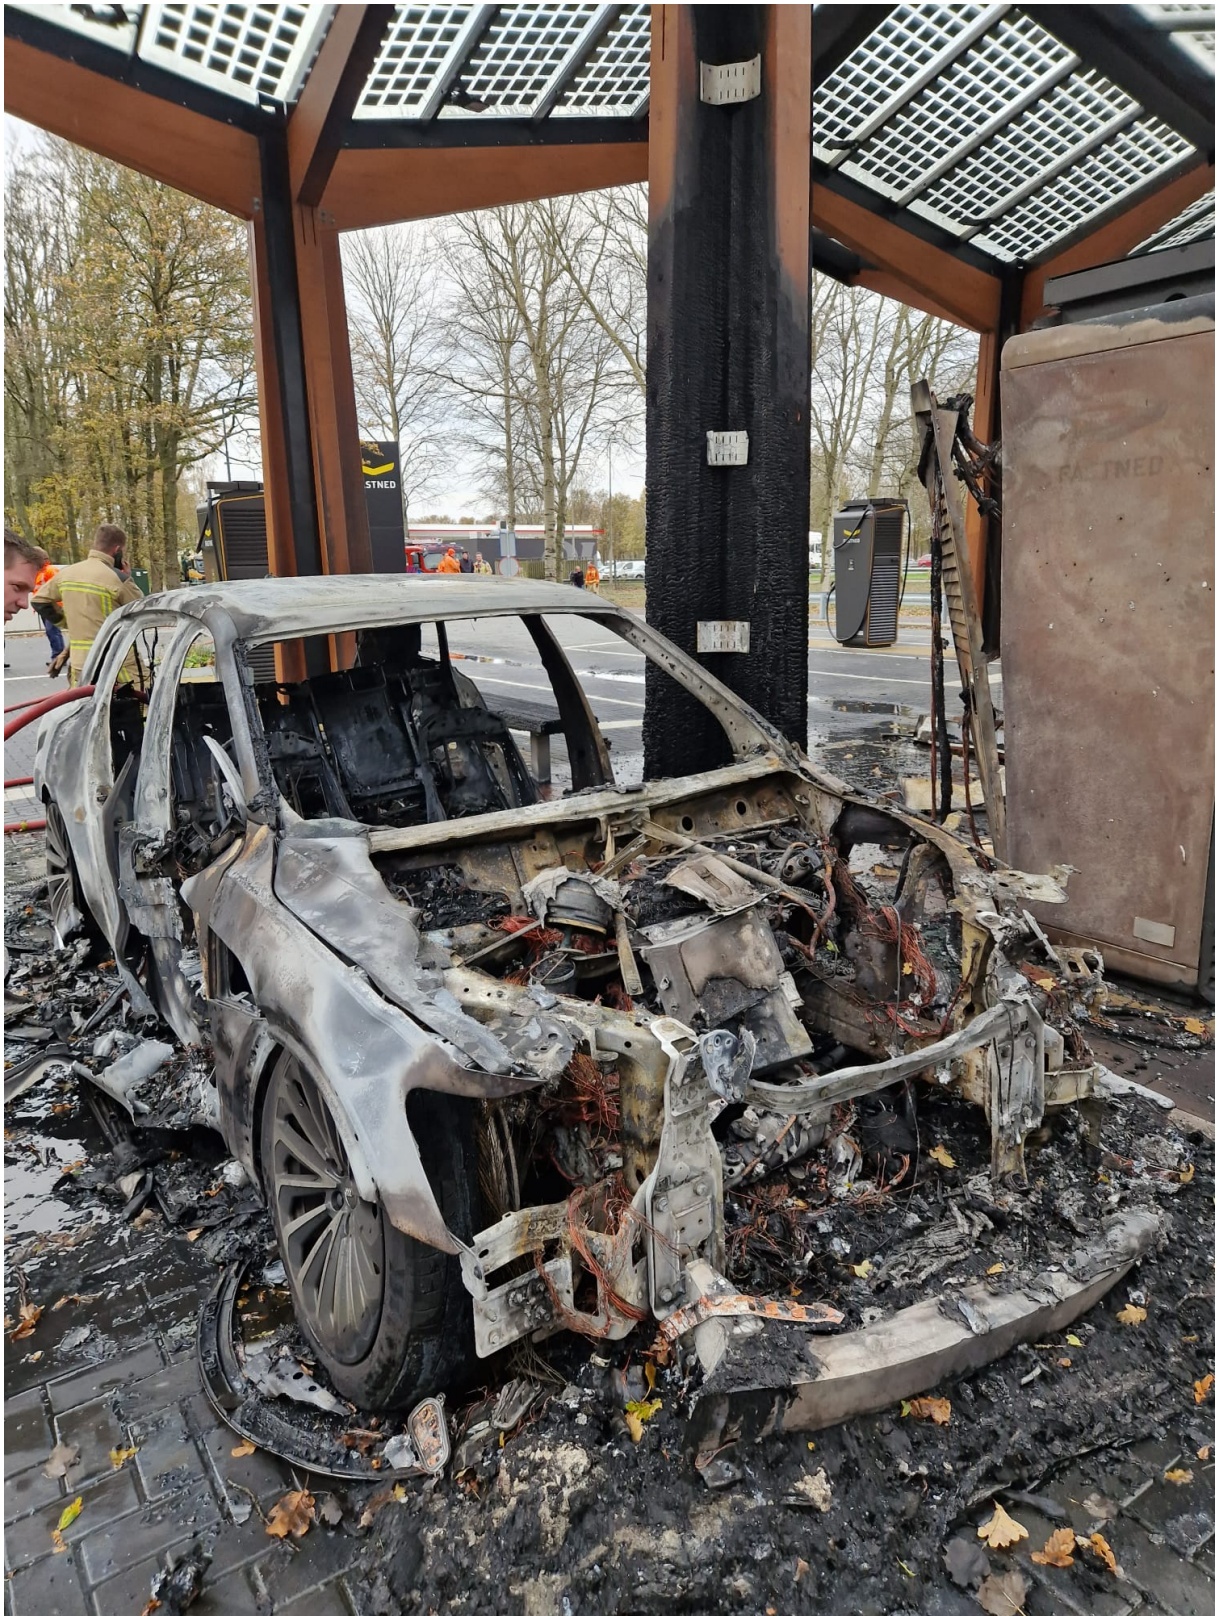
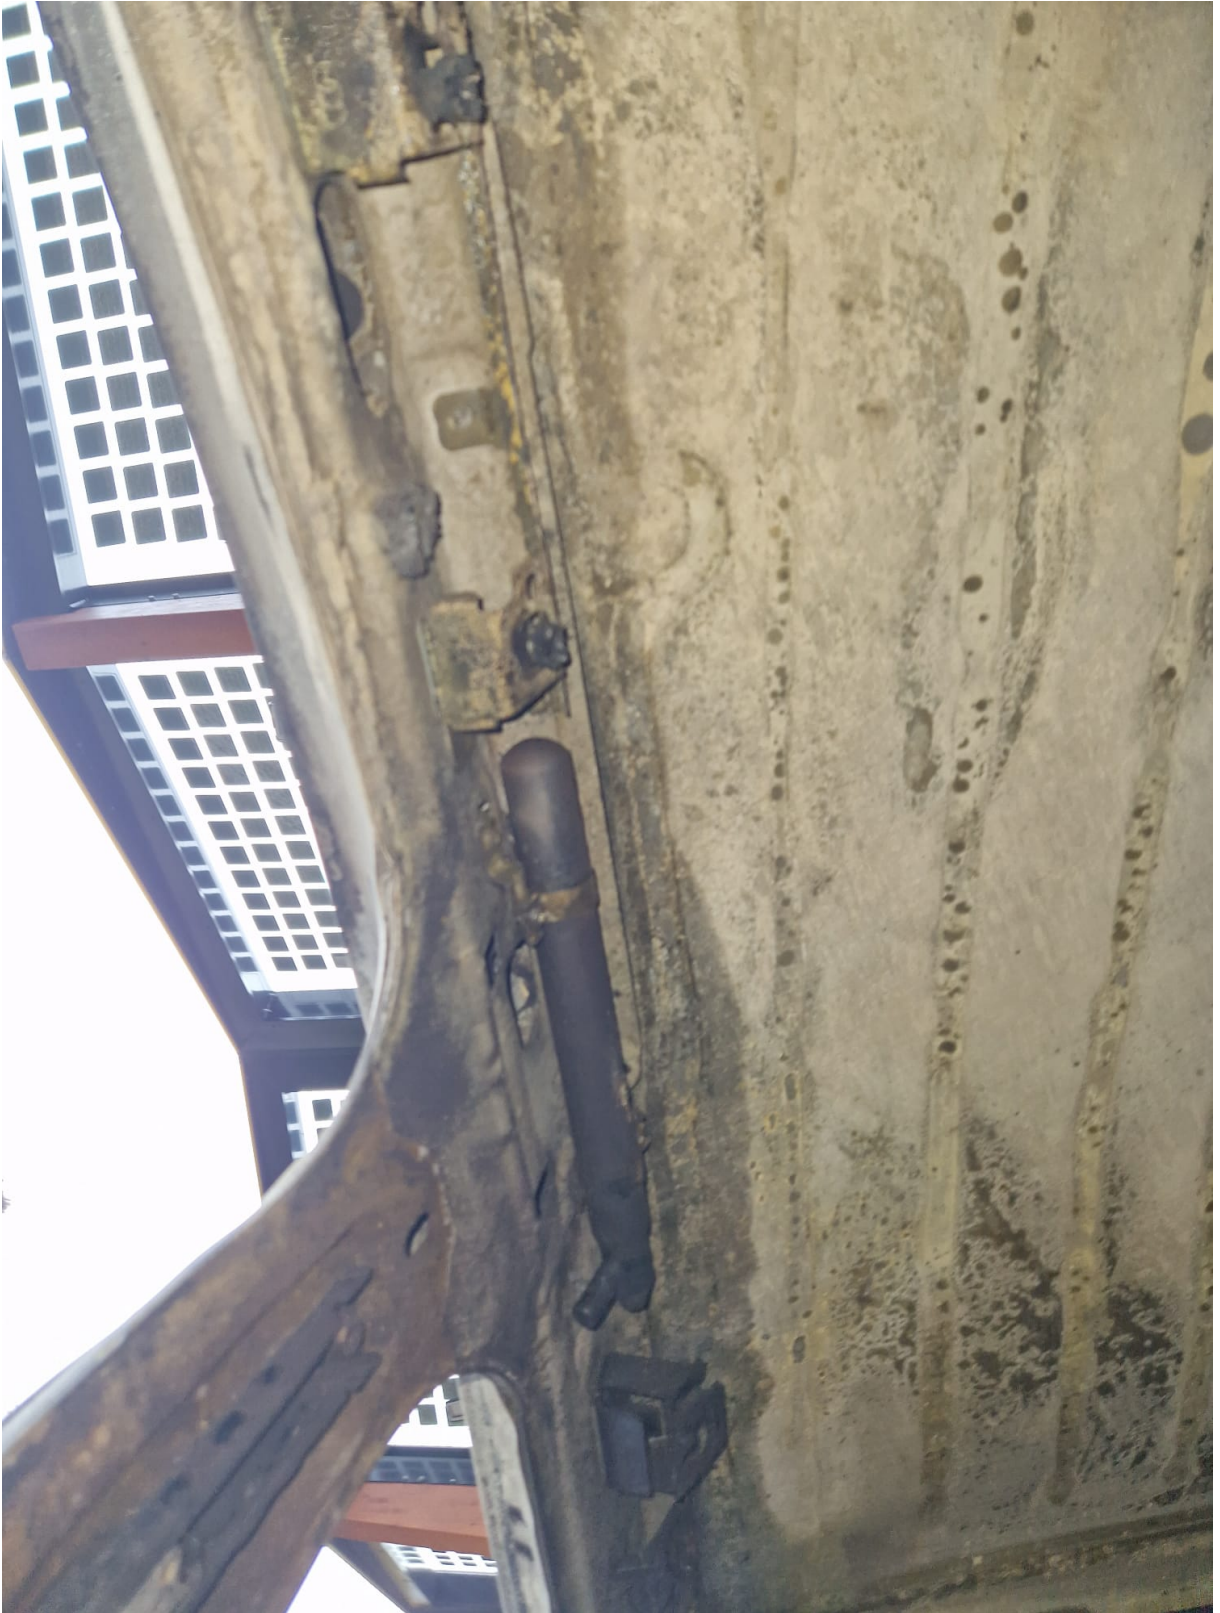
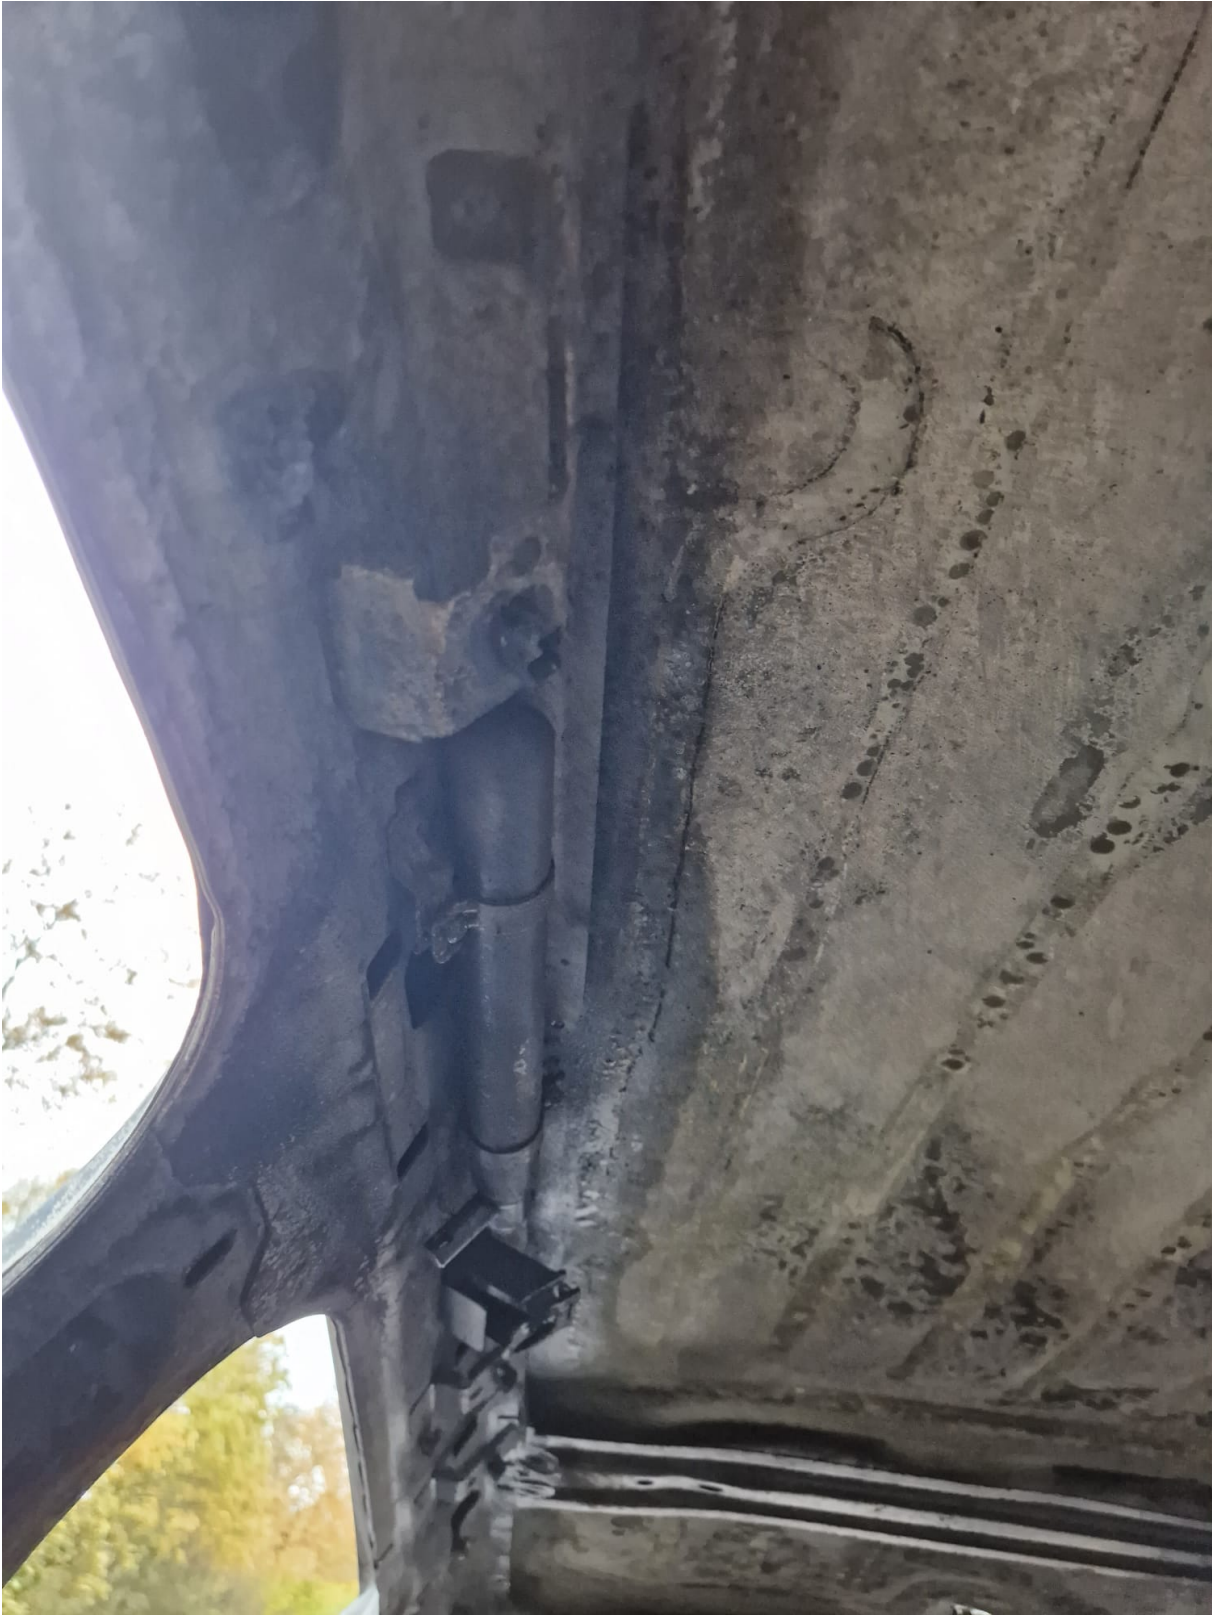
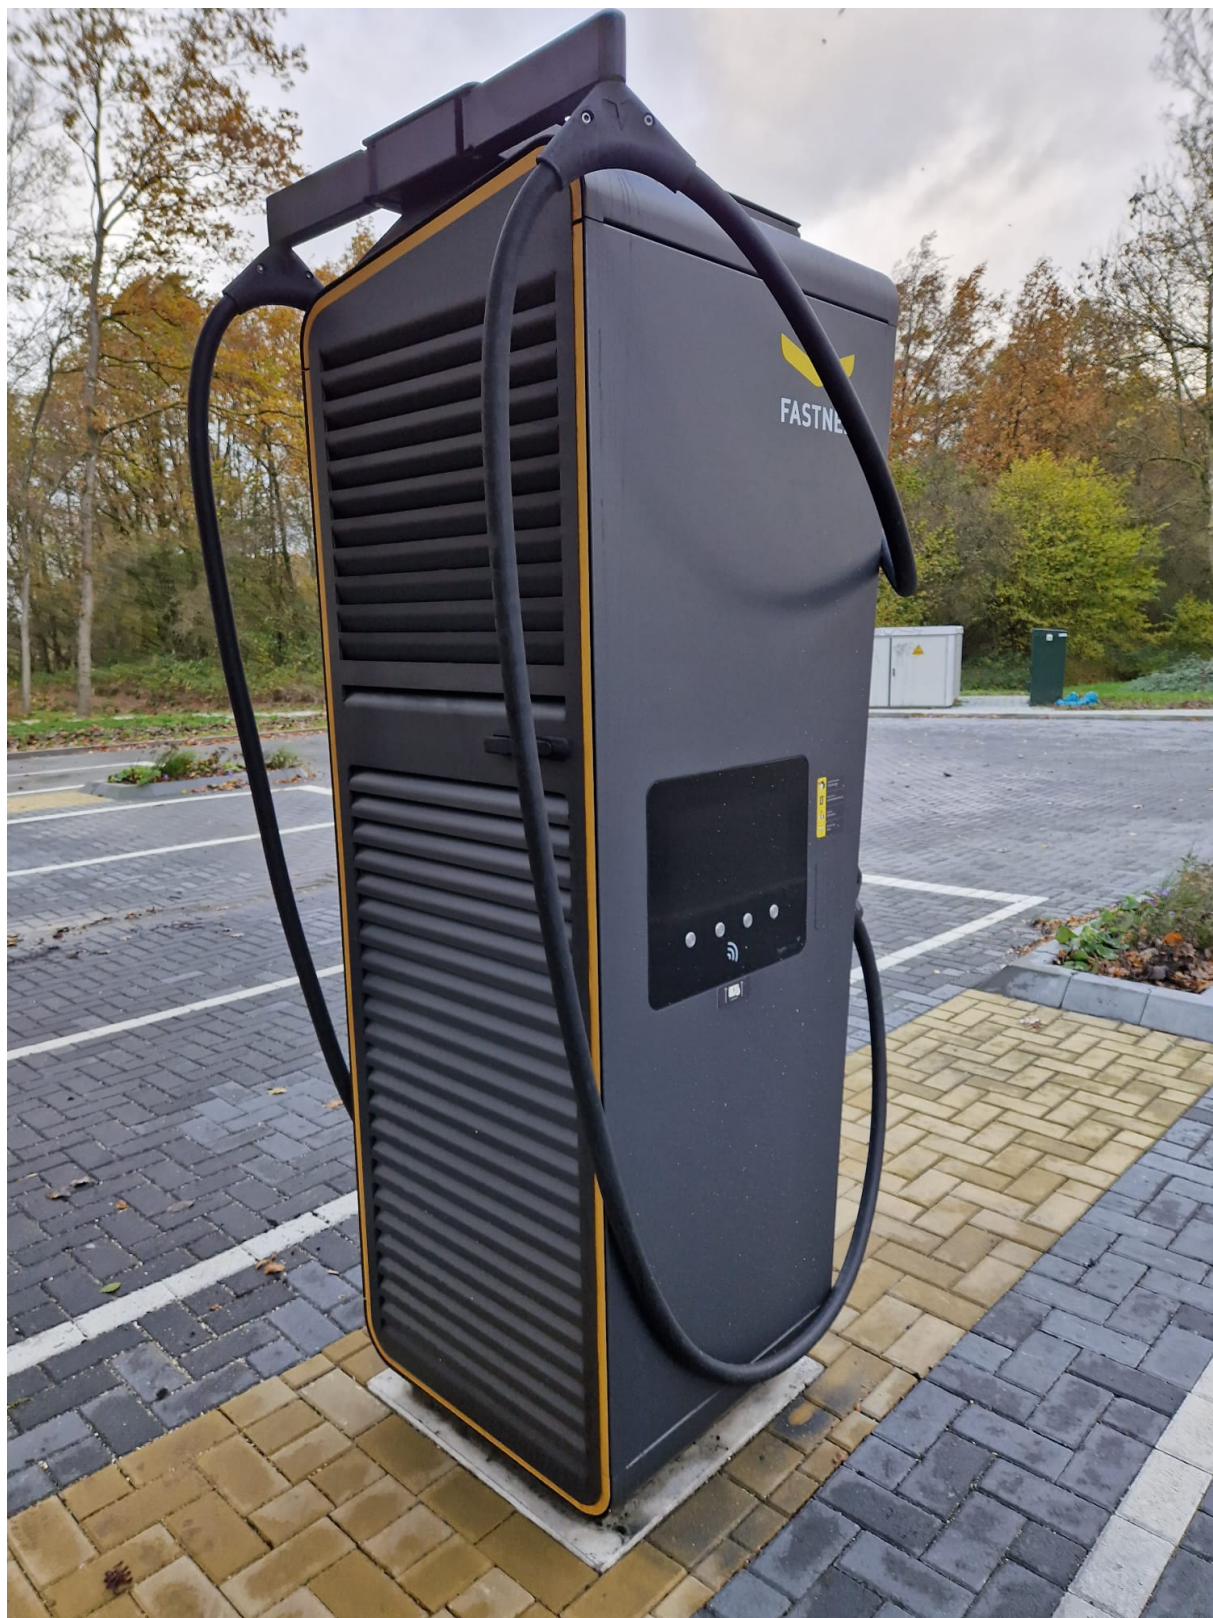
On 23 November 2023, an Audi A4 e-tron is charging at a charger of the Fastned charging station. With the driver inside the vehicle, after about 20 minutes at the charger, a bang is heard from underneath the car, after which smoke and fire develop.

The fire has spread to the charging station. See the attached series of photos for a picture of the situation.

- Little was left of the cabinet itself. The risk was that the charger was still live.
- This could only be done by Enexis; the station operator also had no emergency stop or similar available
- The chargers were isolated via the transformer on site > grid operator / operator Fastned

- Car was more or less allowed to burn out, with the attack focused on the canopy.
- Extinguished with spray foam
- Keep a safe distance because of exploding vehicle parts

- The Audi's battery appeared stable after the fire; the assumption was that all cells had burned out, so the fuel was consumed > have the recovery company remove the vehicle in a water container
- Canopy structure > municipal building inspection (BoWoTo)
- Handover of the charging station to the operator/owner, cordoned off with construction fencing > Fastned
