## Burning car at a Fastned charging station in Beilen

# Case debrief: fire at the Fastned station in Beilen on 23 November 2023

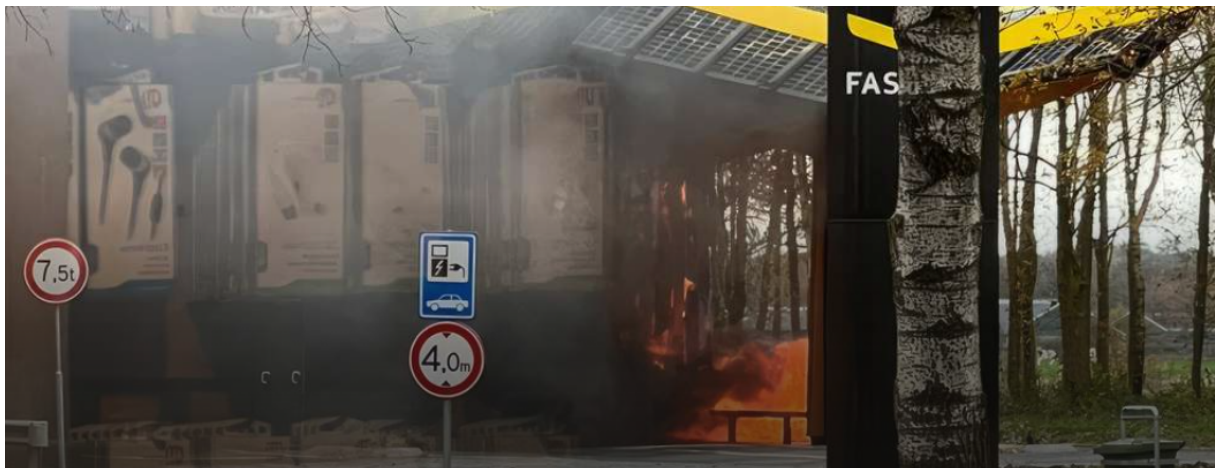
On 23 November 2023, an Audi A4 e-tron is charging at a charger of the Fastned charging station. With the driver inside the vehicle, after about 20 minutes at the charger, a bang is heard from underneath the car, after which smoke and fire develop.

The fire has spread to the charging station. See the attached series of photos for a picture of the situation.
